# TECH NOTE

No. 003

## Uneven Fuel Feeding in Single Engine Cessnas

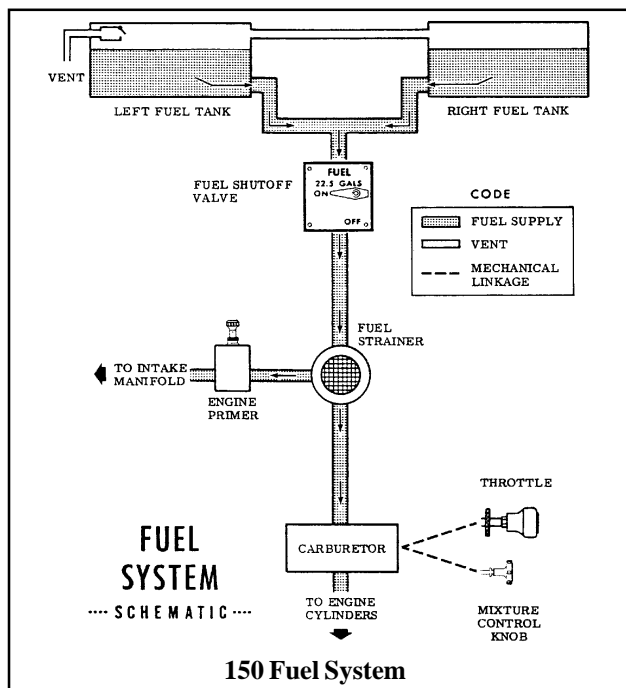
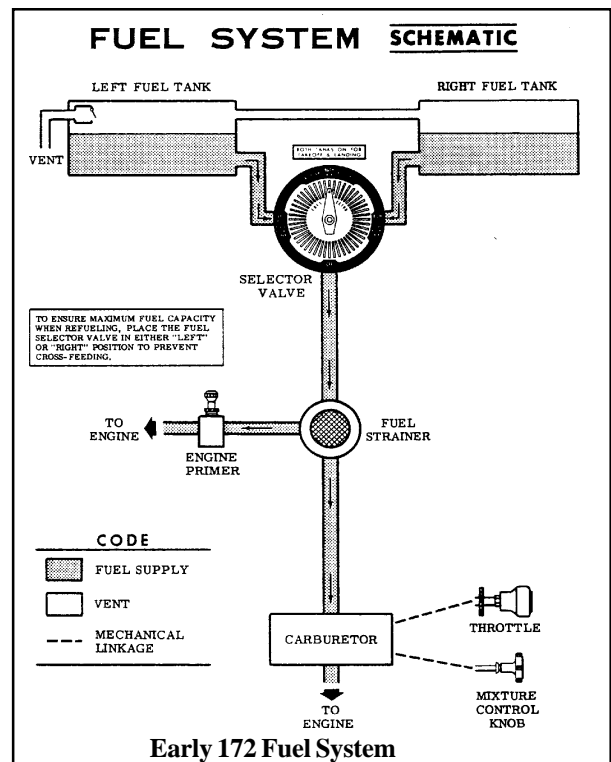
To prevent dire consequences such as listed above, the fuel tanks are vented to the outside and air is allowed to replace fuel as it is used. On most single engine Cessnas with carburetted engines a single "L" shaped vent tube that is located behind the left lift strut is used. This vent tube is connected by hosing and tubing to the outboard portion of the left fuel tank. As fuel is used from the left tank it is replaced by air from the outside. This takes care of the venting of the left tank. But how about the right tank?

It was in venting the right tank that Cessna engineered a novel but, as it turned out, not very satisfactory solution. Knowing that the right tank had to be vented and also knowing that the head pressure in the right tank had to be equal to the head pressure in the left tank, Cessna thought they could accomplish both tasks at the same time. The engineers reasoned that if they connected the top of the left

tank to the top of the right tank they would be venting the right tank with air from the left tank and the pressures would be equal. A good idea on paper perhaps but not such a good one in practice.

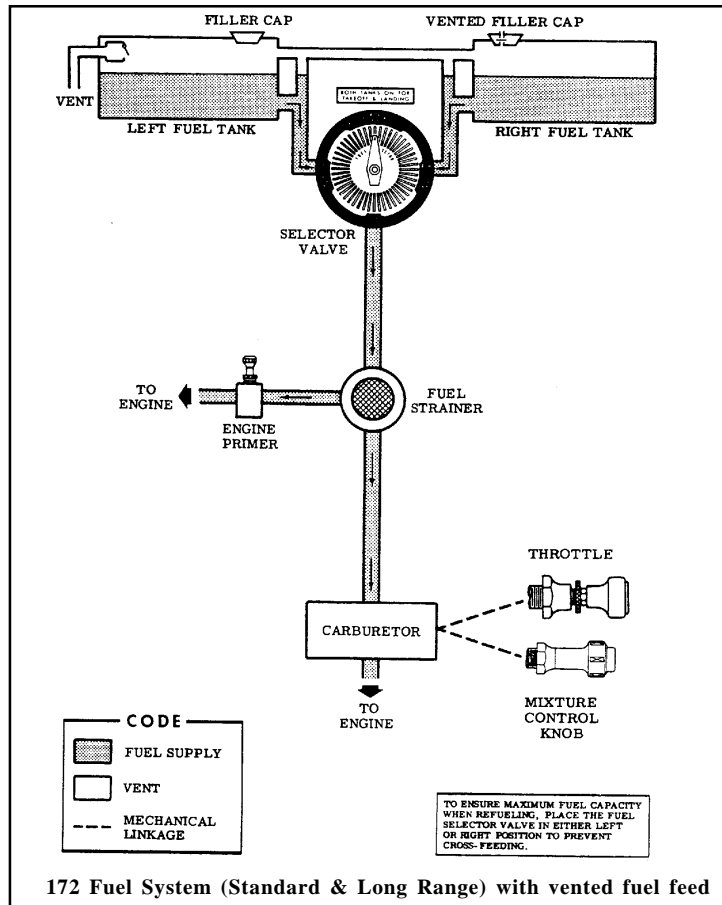
What the engineers hadn't given proper consideration to was wing dihedral and fuel slosh. Cessna wing tanks can be very long and shallow, on the 182 Skylane the long range tank is only 8" deep but is 7 feet long! This shallow, wide shape makes the fuel feed very sensitive to tank, or head, pressure. Wing dihedral places the outboard portion of the fuel tank above the inboard portion, sometimes by as much as several inches. This means that when the tanks are full the vent interconnect line is below the fuel level and is full of fuel. When air enters the left tank to replace fuel being used, the pressure pushes fuel from the left tank through the vent interconnect into the right tank, replacing any fuel that has been used from the right tank. In this manner the right tank

can remain full even while fuel is being used from it while the left tank goes down even faster than fuel is being fed to the engine from it! This transferring of fuel from the left tank to the right tank will continue until the fuel level in the left tank drops below the height of the vent interconnect line. In fact the fuel transfer can continue for awhile even after the fuel level in the left tank has dropped below the height of the vent interconnect line because motion in flight will tend to slosh some fuel into the vent interconnect line from time to time and this fuel will be pushed/pulled into the right tank. It is only when the fuel level in the left tank is so low, usually around half tank level, that none of the remaining fuel in the left tank can make it's way to the vent interconnect line that the fuel passage from the left tank to the right tank will stop.

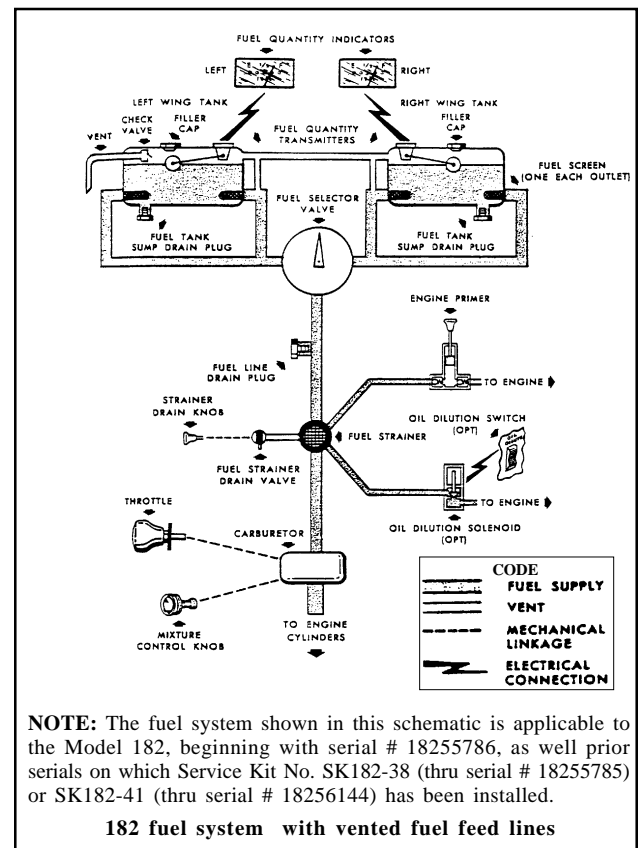
**NOTE:** The fuel system shown in this schematic is applicable to the Model 182, beginning with serial # 18255786, as well prior serials on which Service Kit No. SK182-38 (thru serial # 18255785) or SK182-41 (thru serial # 18256144) has been installed.

Cessna, hearing complaints from owners on uneven fuel feeding, tried several things to improve the situation. With the 182 with long range tanks they extended the vent interconnect lines inside the tanks along the top to the outboard edge of the tanks. This began with long range tanks installed in the 1964 182G, s/n 18255059. The idea was that this would raise the vent interconnect line above the fuel level in all cases except with absolutely full tanks. This idea might have worked fairly well except that about the same time, beginning with s/n 18255786 and on, the engineers made another change to the 182's fuel system. Having suspicions that the problem was related to unequal pressures in the tanks, they made an attempt to equalize pressure through out the system as much as possible by venting the forward fuel feed lines to the vent interconnect line running across the top of the fuselage. What this actually does is permit fuel to move from one tank to the other any time there is different head pressure in the tanks, even if the fuel level in the tank is below the height of the vent interconnect line. What will happen is that the tank with the higher head pressure will push fuel through the forward fuel feed line up to the vent interconnect line, across the top of the cabin and

down into the vent line for the forward fuel feed line of the other tank (See Drawing). There can be a number of causes of this uneven head pressure which will be discussed a little further on.

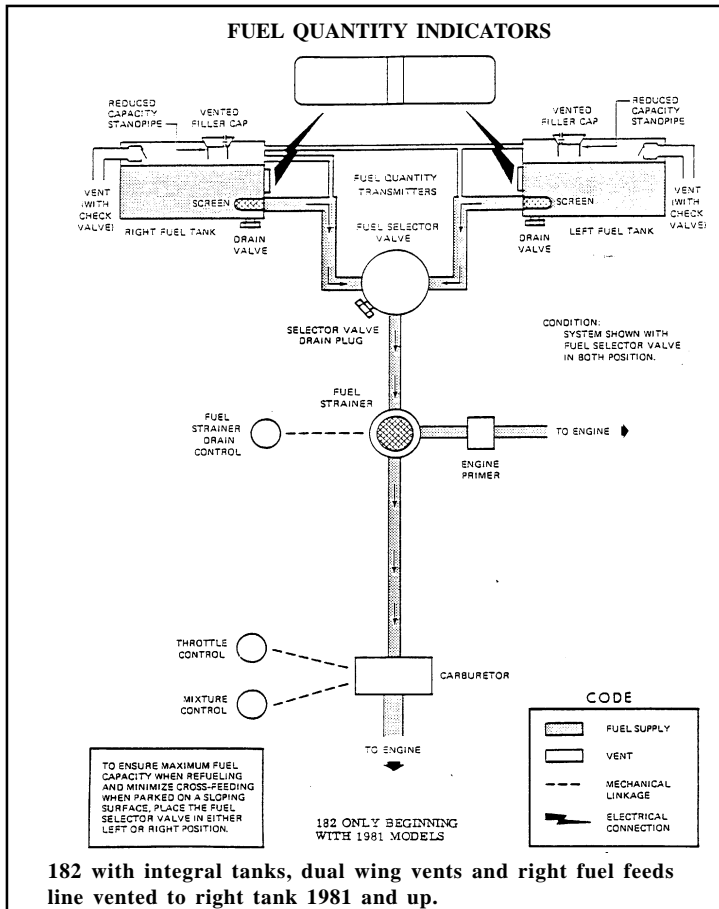
performance. The idea is that the vent tube 'hides' behind the lift strut to gain some ice protection and has just a small area protruding into the ram air. The positioning of this vent is so critical that Cessna calls out the dimension in hundredths of an inch. It is possible to make some minor adjustments on both the single vent and dual vent aircraft. Keeping in mind that the tank with the greatest head pressure will

feed the fastest, if you want to reduce the head pressure in that tank move the "L" shaped vent tube, which is held in place by an Adel clamp that is accessible through an inspection cover near the vent tube, up and in which will place it more behind the lift strut and reduce the amount of ram air the tank receives. If you wish to increase the head pressure move the vent tube down and out. A couple of cautions in playing around with vent tube location away from the setting specified in the service manual; First make sure that you have looked at all other possible problem areas. Second, make very minor adjustments and check the results rather than making major adjustments. Studies made while STCs for engine upgrades and engine

There can also be a problem caused by the lift strut fairing that is positioned in front of the "L" shaped vent tube. Air flow along the bottom surface of the wing can enter this fairing where it mates to the wing and come out the fairing right in front of the vent tube. This high pressure, disturbed air burbling at the entry to the vent tube can have a very significant effect on venting pressures. To prevent this Cessna calls out for installing a seal at the bottom of the fairing on the inside to prevent air leakage in front of the vent. A nice little Saturday morning project for an owner is to drop the fairing down the strut, look inside to see if the seal is present and in good condition and if not replace it with some simple screen door rubber seal available about anywhere.
